**2016/SOM3/EPWG/008**

## **2016 Kumamoto Earthquake Survey Report**

## 2016 Kumamoto Earthquake Survey Report (Preliminary)

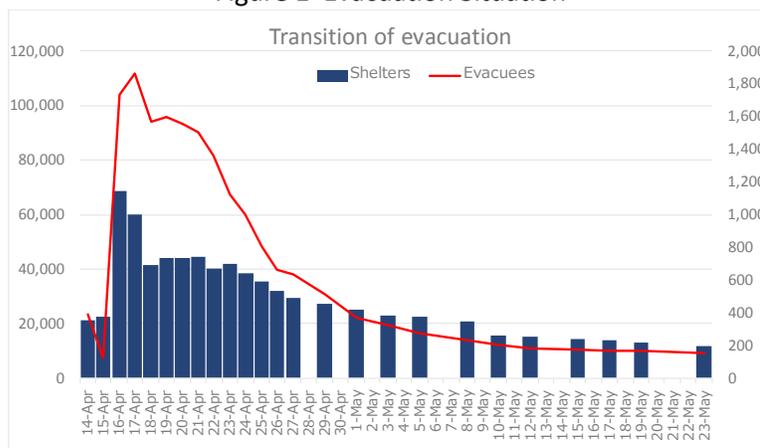
Figure 1 Evacuation Situation

Affected municipal governments provided gymnasiums and other public buildings for use as public shelters for affected residents who could not live in their damaged houses in Kumamoto, Oita, Nagasaki, and Fukuoka Prefectures. The peak numbers recorded were 855 shelters and 183,882 evacuees as of 17 April. There were 198 shelters and 8,911 evacuees as of 23 May. Public shelters except Kumamoto Pref. were closed by 16 May.

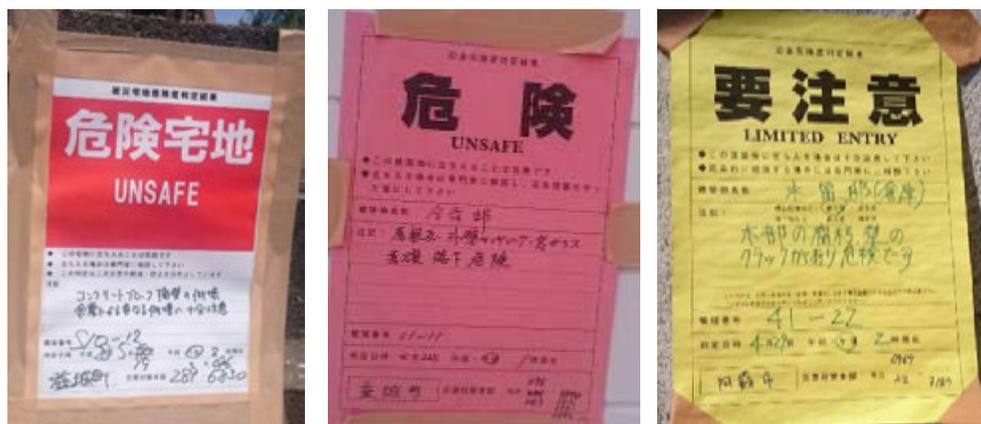
Photo 2 Emergency safety evaluation for buildings and urbanized sites

architects conduct “Post-earthquake Quick Inspection of Damaged Buildings” to assess safely to buildings to withstand aftershocks, while insurance companies conduct damage investigations for earthquake insurance payments. The post-earthquake quick inspection of damaged buildings began on 15 April in Mashiki and on 16 April in other municipalities, with the support of other local governments in Japan and private architects. It is important that the necessary inspections are quickly and comprehensively performed after a disaster, and that greater efforts are made to widely disseminate information about the purpose of these systems.

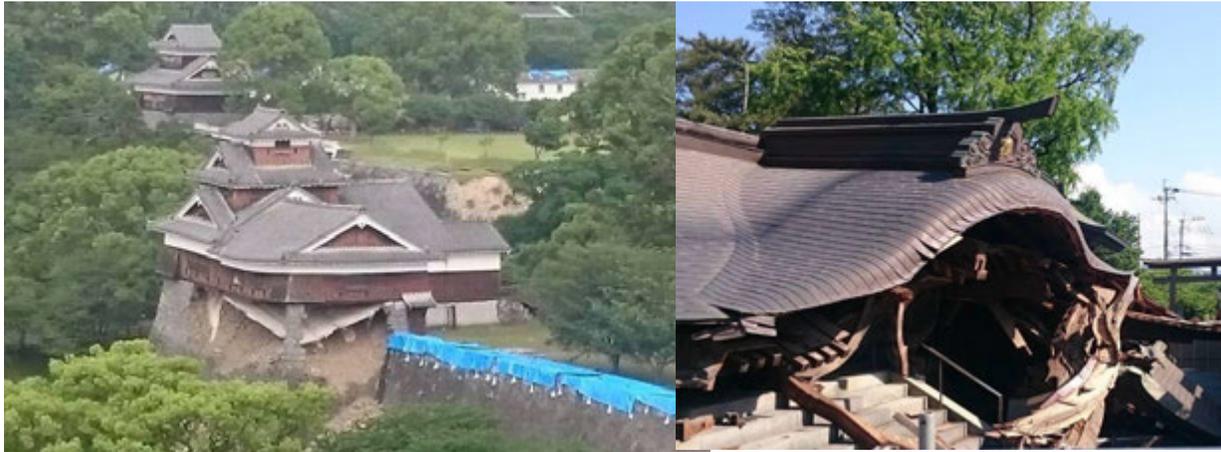
Photo 3 Damaged Kumamoto Castle and Aso Shrine

Kumamoto Castle, a symbol of Kumamoto Prefecture, which was built in the 16th century, has been designated as an important cultural property Japan. Its walls and turret were severely damaged by the earthquakes. It is feared that it will take a lot of money and time to repair the damage. At Aso shrine, which is said to have been founded in the 3rd century BC, the tower gate and hall of worship were severely damaged. Other buildings that are not classified as historic buildings, were also damaged Aso Ohashi, Red Bridge, for example, which is regarded as a civil engineering heritage, was swept away by a large-scale landslide.
